STRESS CORROSION FAILURE OF A LOW PRESSURE DISK FROM A 800 MW STEAM TURBINE

ASIA TURBOMACHINERY & JUMP SYMPOSIUM
SINGAPORE | 22 - 25 FEBRUARY 2011
MARINA BAY SANDS

This case study discusses the root cause analysis of a recent stress corrosion failure of a low pressure disk from a 800 MW steam turbine. Turbine disk modifications to prevent future stress corrosion cracking are detailed.

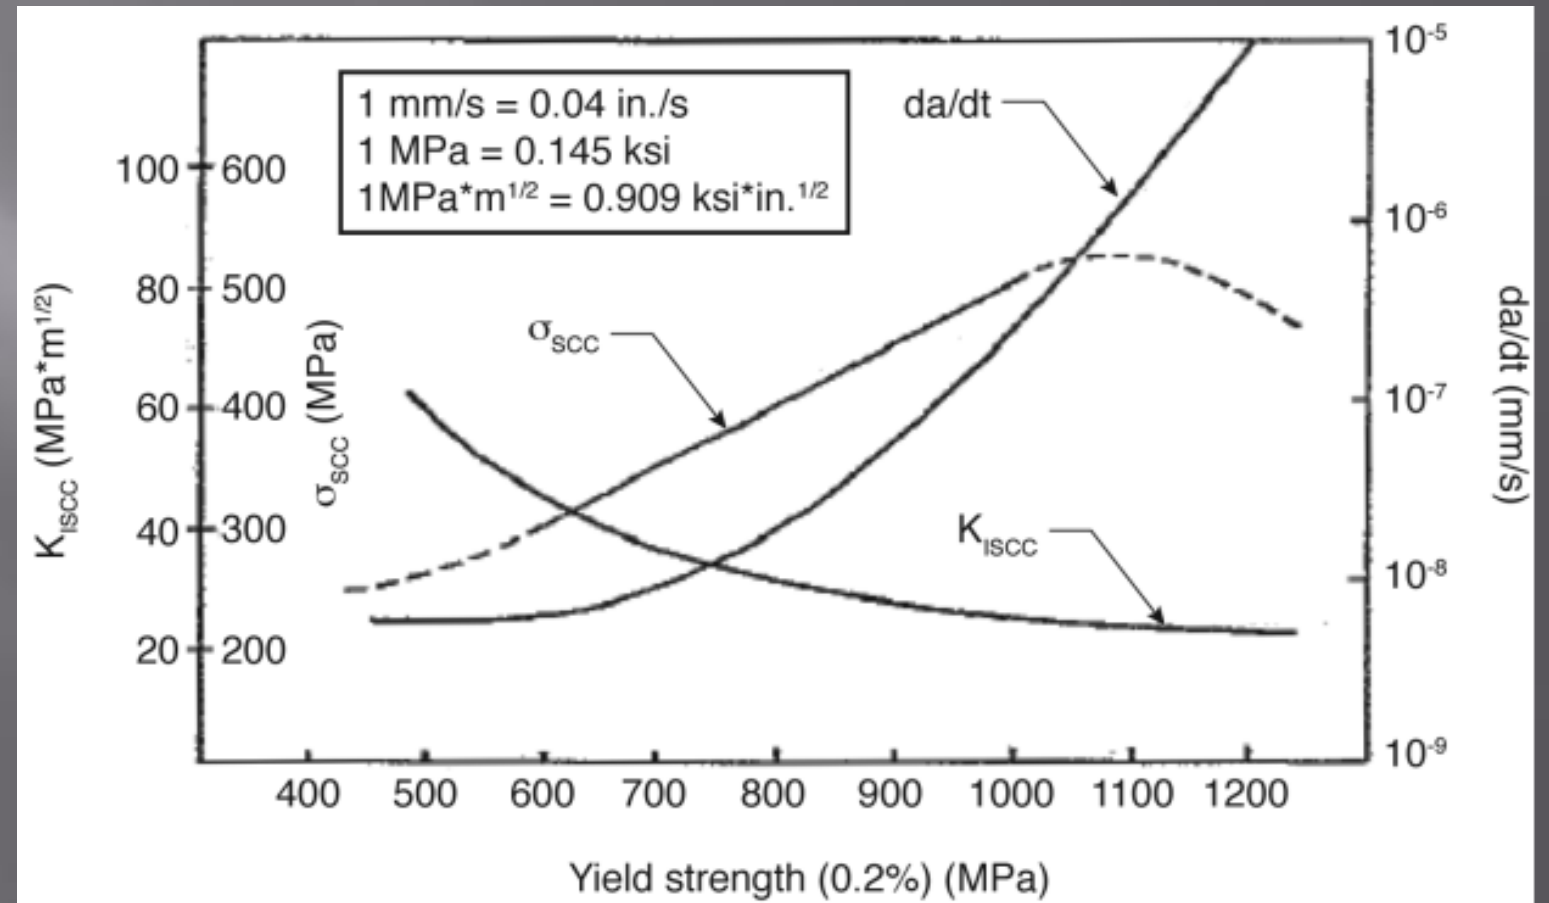
Stress Corrosion Cracking

- ▣ Variables
 - Material
 - Stress
 - Environment
 - Time

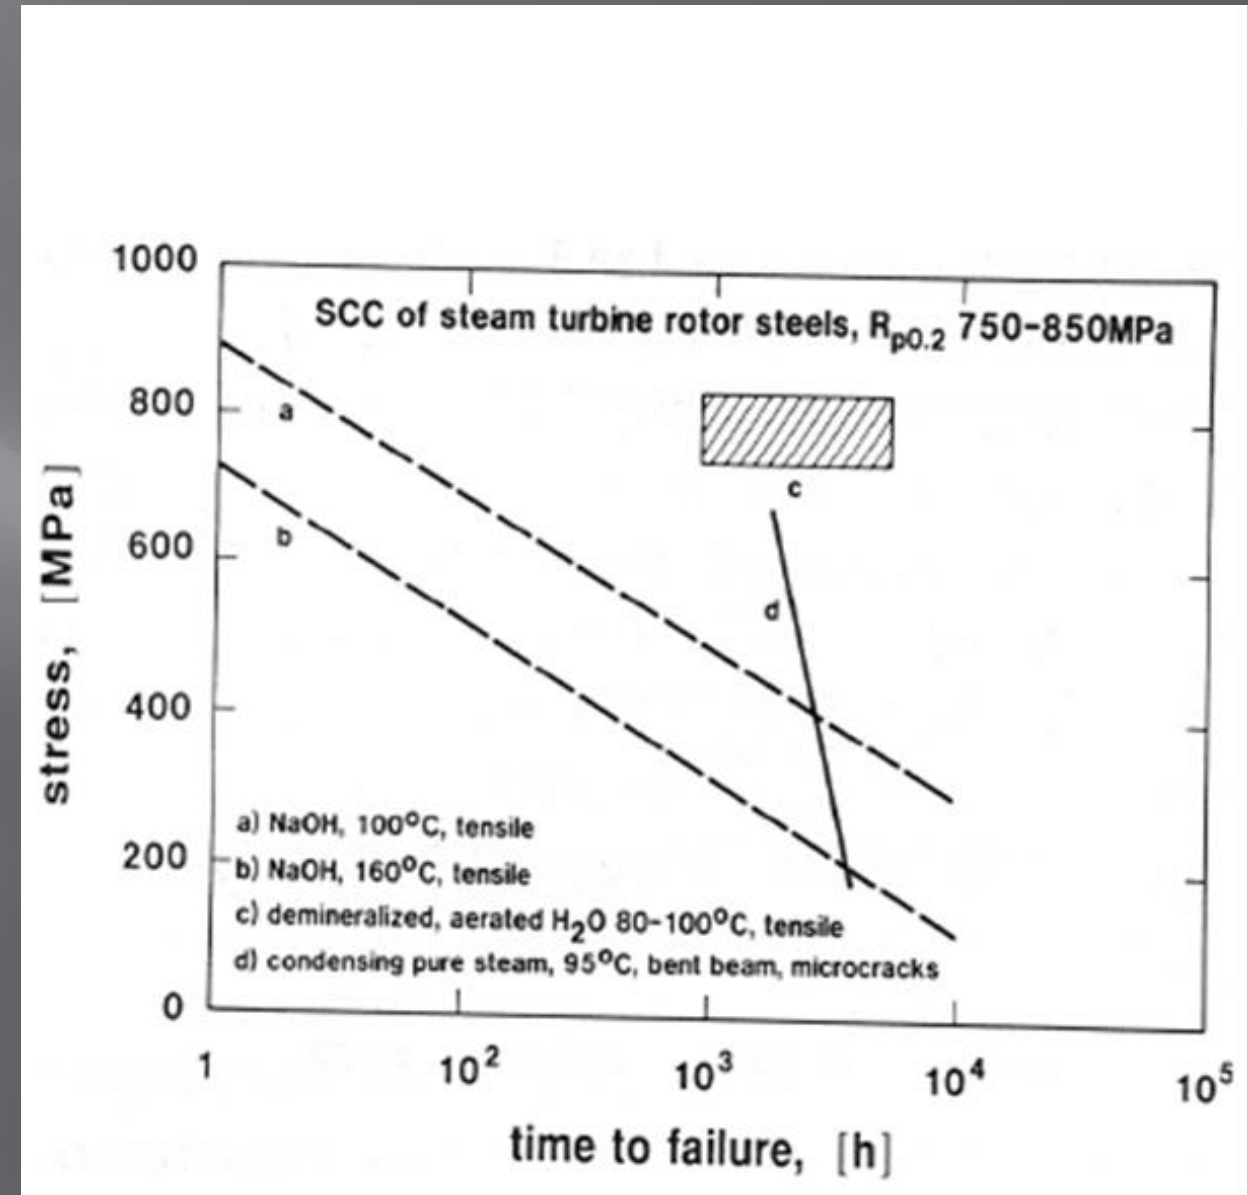
- ▣ Operating Time Affects Stress Corrosion Cracking
 - Concentration of Precipitates in Crevices
 - ▣ Shut Down/Start-Up
 - ▣ Partial Loading
 - Initiation and Propagation
